FACEPLATE

The Official Newsletter for the Divers and Salvors of the United States Navy
Volume 6, No.1 / March 2002

THE RECOVERY OF THE EHIME MARU

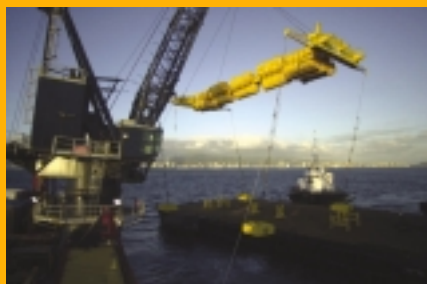
The lower lifting rig that will be used to relocate the sunken Japanese fishing vessel EHIME MARU is lifted from a barge off the coast of Oahu, Hawaii. Photo by PHC(SW/NAC) Spike Call.

The concept of operations called for placing two large lifting straps beneath the ship and carrying it into shallow water where divers could safely enter and search the vessel. This required that a site be chosen where the ship could be relocated without causing damage to the environment. To prove this, CINCPACFLT had to accomplish an Environmental Assessment before the operation could begin. CINCPACFLT N45 (Environmental Division) was chosen to head up this effort. Drawing on assistance from EDAW Inc. from Irvine, CA, numerous subcontractors, NAVSEA 00C25 pollution engineers, and SUPSALV Emergency Ship Salvage Material (ESSM) contractor personnel, CINCPACFLT N45 conducted the assessment in less than 13 weeks at a cost of nearly \$2 million. The Environmental Assessment culminated with (CINCPACFLT) signing a "Finding of No Significant Impact" (FONSI) for moving EHIME MARU from its current location to about a mile off the Honolulu airport.

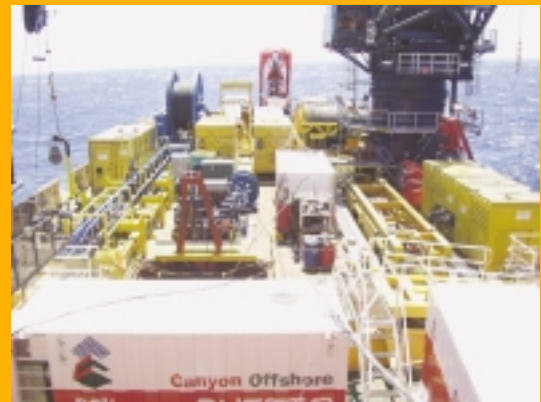
On the aft deck of the ROCKWATER 2 is equipment that will be used in the recovery of EHIME MARU. Photo by PH3 Joshua L. Pritekel.

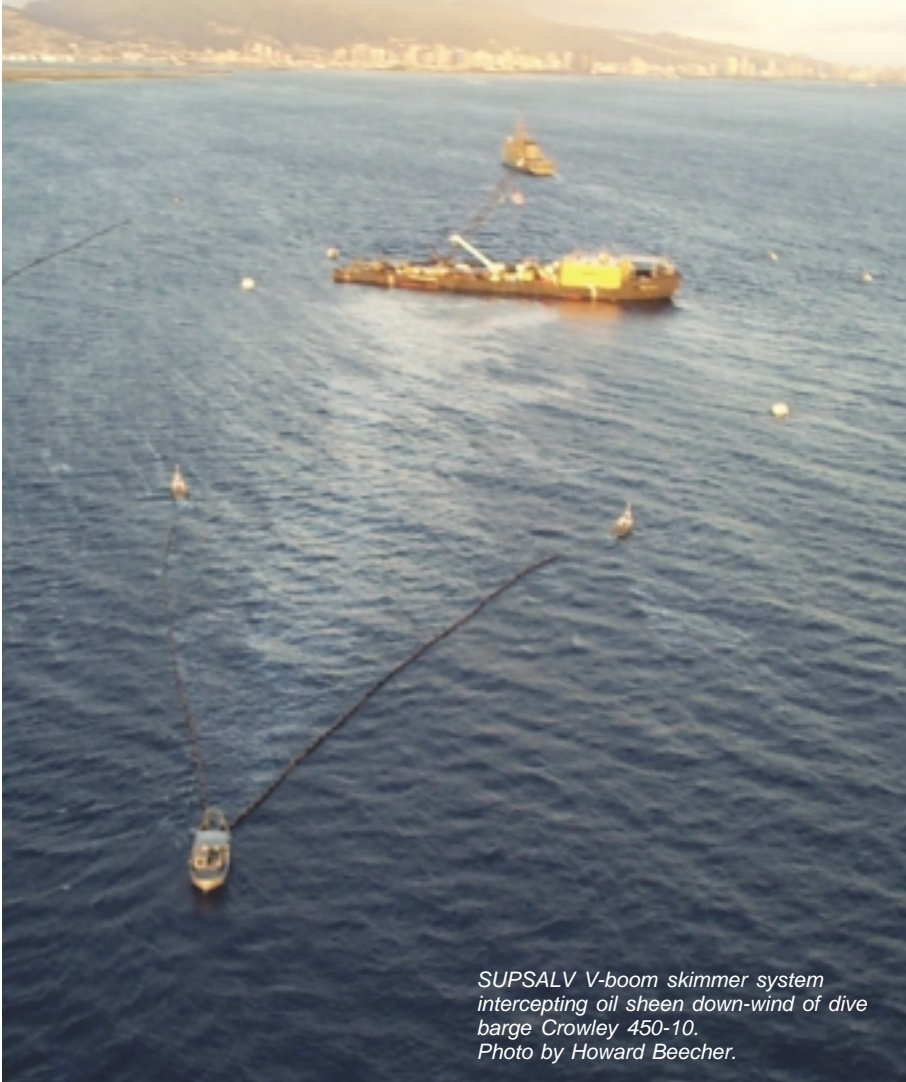
SUPSALV V-boom skimmer system intercepting oil sheen down-wind of dive barge Crowley 450-10. Photo by Howard Beecher.

The EHIME MARU environmental protection plan was implemented as planned. As expected, very little oil remained on board due to collision damage and probably also due to partially filled tanks being crushed as the vessel rapidly descended to 2000 feet. Very little oil was released to the environment during recovery operations. Oil that was released formed very light sheens on the surface that rapidly dissipated naturally.

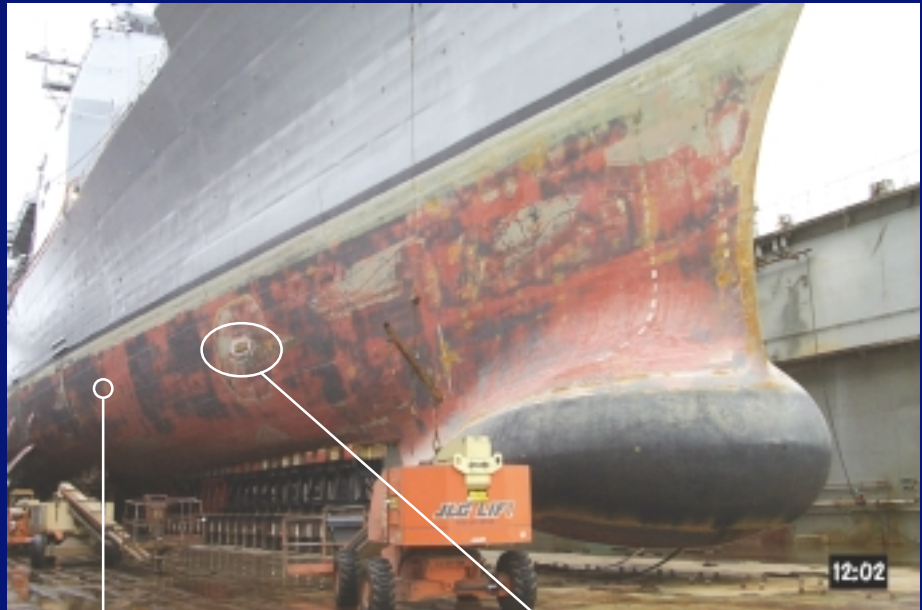
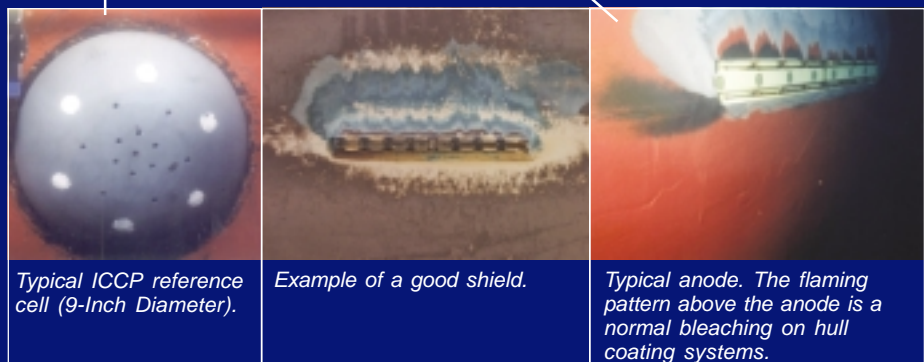
Forward 4-foot long anode and dielectric shield.

The ICCP system plays a vital role in preventing corrosion of underwater portions of a ship's hull and appendages. Although the underwater coating system provides the primary barrier to corrosion on all surface ships, submarines, and aircraft carriers, the ICCP system protects the hull and appendages when the coating system is damaged and the underlying steel is exposed to seawater. The ICCP system is designed to protect up to 12 percent bare metal. The ICCP system provides insurance that these bare metal areas are adequately protected until the anti-corrosion coating can be replaced either waterborne or in drydock. Whenever the ICCP system is secured, the ship loses the ability to prevent corrosion in areas where the coating has been damaged. Corrosion is most severe when the ICCP system is de-energized for extended periods. The frequency and duration of inactivation of the ICCP system should be minimized.

- When divers are required to work close to an active ICCP anode and there is a risk of contact with the anode, the system must also be secured.
- In situations other than those described above, the ICCP is to remain active.
- Divers working within 15 feet of active systems must wear a full dry suit, unisuit, or wet suit with hood and gloves.

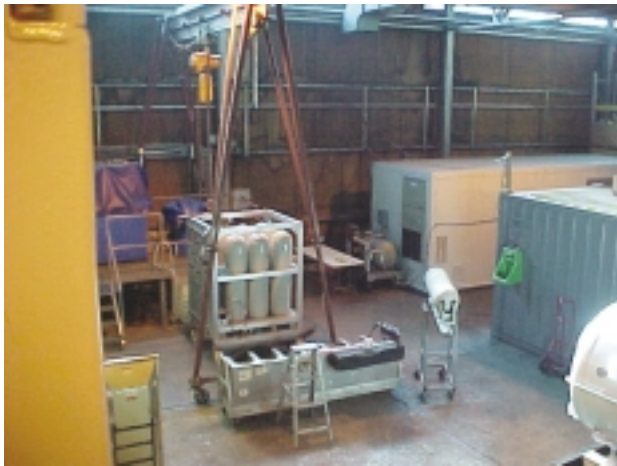
FADS III flasks being hydrostatic tested.

The ESSM CAX facility has the ability to perform almost all functions required for maintenance and repair of DLSS equipment. Where this facility does not have a needed capability, they have the ability to contract out for the needed work. One of the first capabilities that we added to ESSM CAX was the ability to perform hydrostatic testing of cylinders, flasks, volume tanks and filter housings. With the advent of the portable systems like the Lightweight Dive System (LWDS) and the Flyaway Dive System (FADS) III that use composite flasks, this has been an important part of what we do. Another important capability established was the ability to clean DLSS systems and components to MIL-STD 1330D. No complete depot capability was possible without this ability. ESSM Diving Depot personnel have also been trained to perform many of the repairs associated with the MK 21 helmet, including regulator repair and adjustment, and helmet shell repairs. The Depot also has the ability to perform gauge calibration for both air and O₂ gauges and can set relief valves as required. Compressor repair and maintenance are also among the capabilities at ESSM CAX. Another capability that is not actually part of the Depot, but uses ESSM personnel outside of the Depot is that of repairing HYDROCOM diver communication boxes. This was a capability that was missing within the Navy for a long time. Within the ESSM CAX facility there are many other capabilities that are used from time to time such as welding, and umbilical assembly pull or strength tests. While the facility at Pearl Harbor does not have all of these capabilities, it does have the ability to perform hydrostatic testing, O₂ cleaning, gauge calibration, and MK 21 helmet repairs.

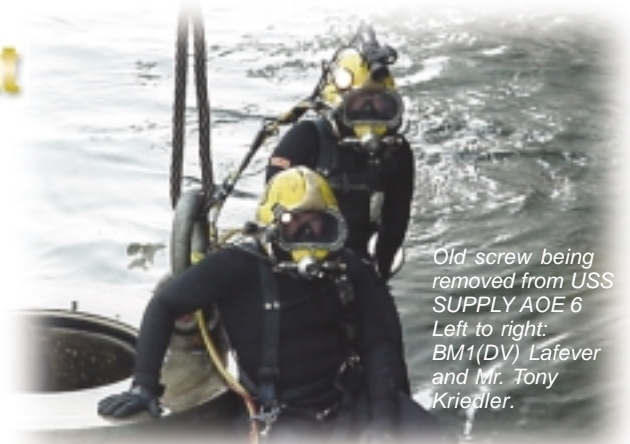
Old screw being removed from USS SUPPLY AOE 6
Left to right:
BM1(DV) Lafever
and Mr. Tony
Kriedler.

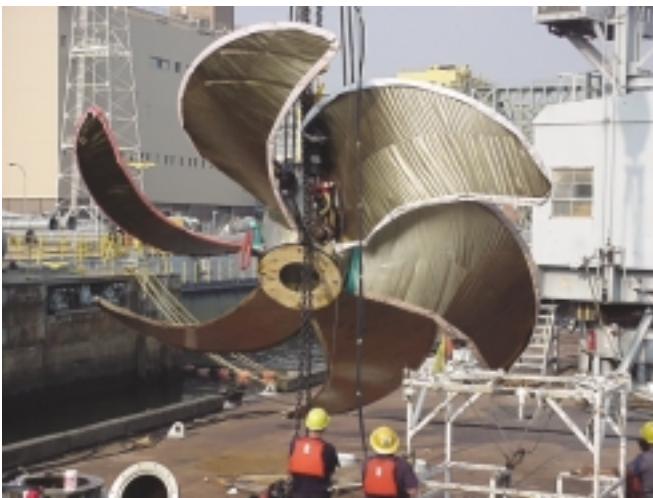
Preparing to install new propeller on USS SUPPLY AOE 6. Left to right: BM1(DV) Lafever and Mr. Tony Kriedler.

The types of jobs SIMA Norfolk accomplishes range from everyday cofferdams and inspections to propeller and auxiliary propulsion motor replacements. The recent 40-ton propeller replacement we successfully accomplished while TAD at Philadelphia Naval Shipyard has been one of the most exciting and rewarding jobs to date of the Diving Regional Repair Center.

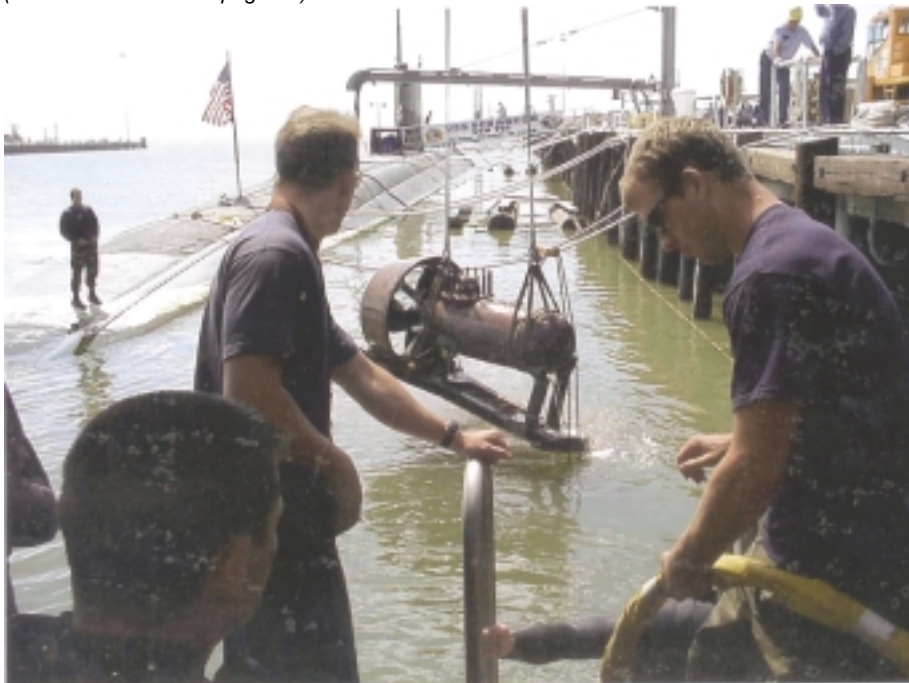
SPM change out on USS SCRANTON. Left to right: HT2(DV) Bennet, BM2(DV) Woods, GM2(DV) Simon, and GMG2 Stradling.
